## Lateral Plungers • smooth, without seal

22150.0032

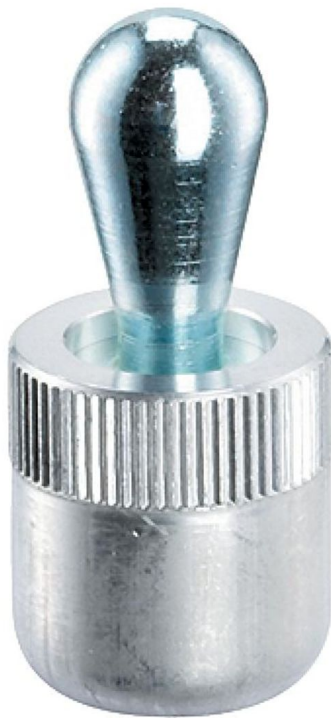
## Product Description

To be used for positioning and applying pressure, e.g. during painting and sandblasting.

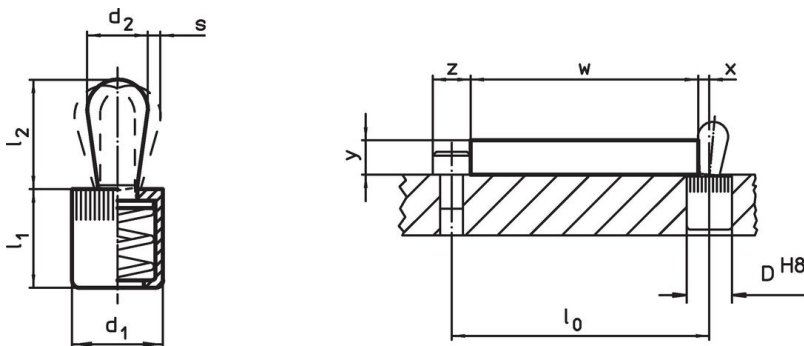
## Drawing

Dimensions		Spring load F max. <sup>1)</sup> ~ [N]	Dimensions		Stroke s [mm]	Location hole D H8 [mm]	max. [°C]	[g]	Art. No.
d <sub>1</sub>	d <sub>2</sub>		l <sub>1</sub> -1	l <sub>2</sub> ±0.5					
[mm]	[mm]		[mm]	[mm]					
12	8	150	13.5	13.6	2.6	12	250	7.8	22150.0032

Formula for calculating the center distance for the mounting hole:

$$l_0 = z/2 + w + x,$$

Calculation dimension  $x$ :

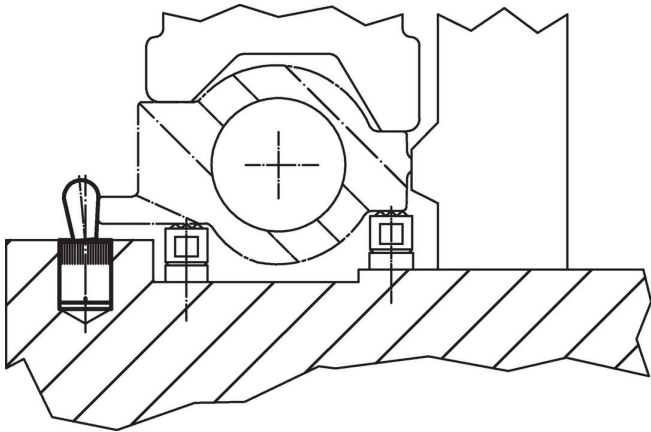
Application example

Installation by pressing in.
