# Lateral Plungers • with thread, without seal, with female thread

22150.1354

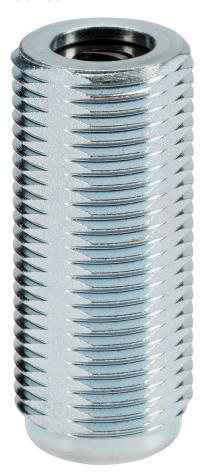
## **Product Description**

To be used for positioning and applying pressure, e.g. during painting and sandblasting.
